Figure 1 – Proposed Pershore Street Development

The site is located off Pershore Street in the centre of Birmingham.

Planning permission was granted for development of an eleven-storey tower building incorporating 333 flats, retail units and a gymnasium / communal lounge. The proposed development is shown in Figure 1 below.

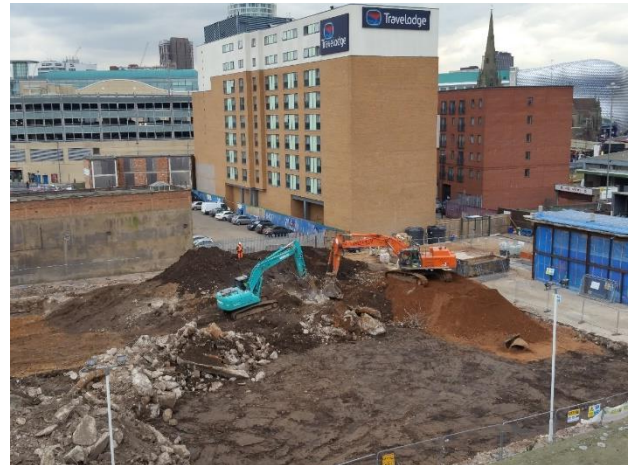
Figure 2 – Photograph showing phased remediation of the Pershore Street Site

Notwithstanding the constraints imposed by the relatively small size and compactness of the site, Envirotrear was able to separate the natural sands and gravels from other soils (to enable local recycling) and also able to ensure that the made ground was suitably managed / delineated (to enable the surplus soils to be disposed of at a local inert landfill facility). The phased remediation of the site is shown in Figure 2.

The works were carried out in accordance with the designated MMP. The floor slab and underlying foundations were removed and set aside for crushing (City Demolition) to produce a grading suitable for reuse within the piling mat. Surplus soils were generated from the underlying natural sands / gravels and from the least contaminated made ground.

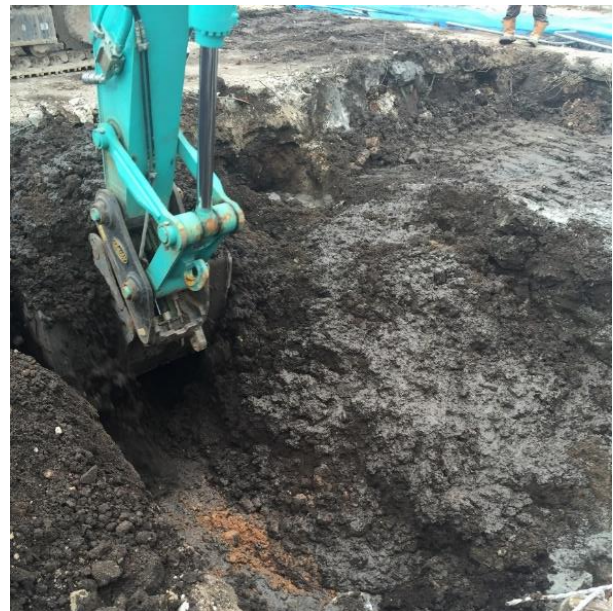
Figure 3 – *In-situ* E-Clay treatment of heavy metal impacted soils.

In order to minimise the size of the soil stockpiles being generated around the site (necessary due to site constraints), Envirotrear treated contaminated soils *in-situ* and removed surplus material offsite as soon as practically possible. There was an implicit requirement to validate the treated soils as soon as practically possible to enable reuse on site.

Envirotreat proposed advanced E-Clay Stabilisation of the contaminated made ground to address the source and pathway risks highlighted in the CSM (to protect the identified receptors). The remediation strategy was approved by the regulatory bodies.

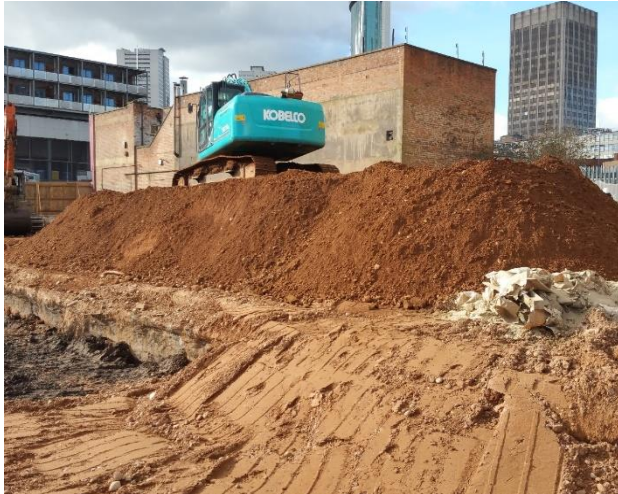
Figure 4 – Stockpiling of natural sands and gravels for subsequent recycling

The excavated / separated natural sands and gravels were temporarily stockpiled prior to offsite removal for recycling purposes (as shown in Figure 4 below).

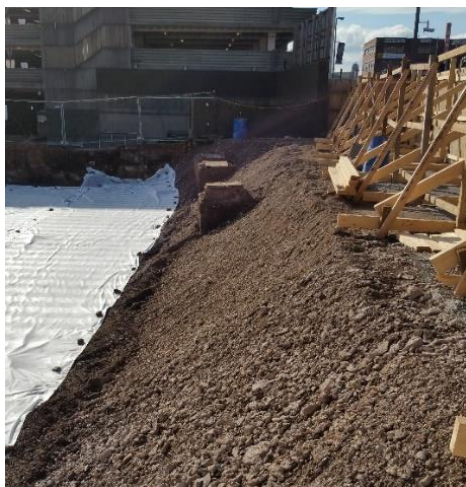
Figure 5 – Temporary works – Batter installed along Pershore Street Side of the Site

Temporary works were required on the site due to height differences between Pershore Street and development formation levels. Envirotreat designed and implemented temporary works to remove the surplus soils and replace with a batter comprising of inert soils (designed to be easily removed at a later date).

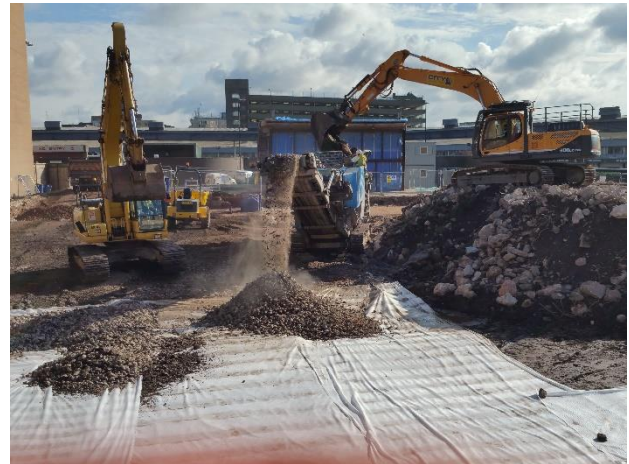
Figure 6 – Provision of piling mat.

Working with City Demolition, Envirotreat utilized site won materials for the construction of a piling mat prior to the main development works

- Reuse of crushed concrete slab and foundation materials providing over 80% of the piling mat requirements
- Recovery / recycling of circa 1,000 tonnes of natural sands and gravels
