The site is the former Cefn Saeson School. The new school development has been completed and the remediation works formed part of the demolition of the old school buildings and infrastructure works to accommodate sports pitches, a bus drop-off and staff car parking.

Sole Providers of E-CLAY® Technology

Remediation Works

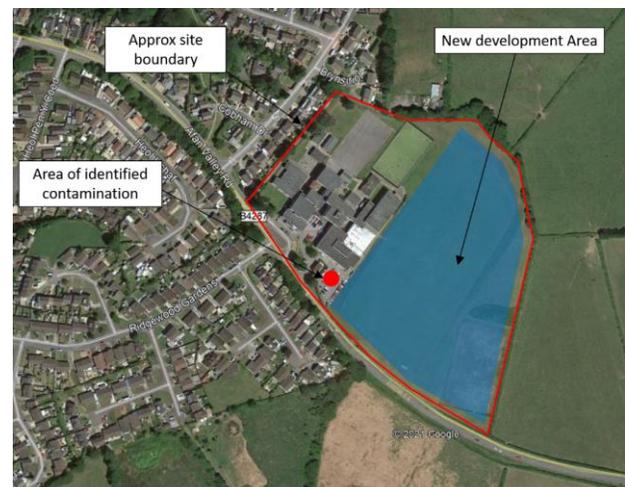
Figure 1 – Contaminated Area

Tetra Tech identified contamination below a tarmacked car park. Contamination was initially identified in WS105 - further exploratory wells were installed around WS105 to delineate the source (i.e. WS201, WS202, WS203 and WS204 respectively). Soil samples taken from WS105 and WS204 were assessed to be hazardous for offsite disposal purposes (following a Haz-Waste-Online assessment).

The prime contaminants of concern were metals (i.e. lead ↑4,390 mg/kg) and zinc ↑7,720 mg/kg) and TPH (↑9,320 mg/kg). The identified contaminated area is shown in Figure 1 below.

Prichard's approached Envirotreat to find a sustainable and commercially viable alternative to offsite disposal. The agreed approach was to treat the contaminated area using E-Clay Stabilisation to enable reuse on-site (E-Clay Stabilisation is licensed as a waste recovery process).

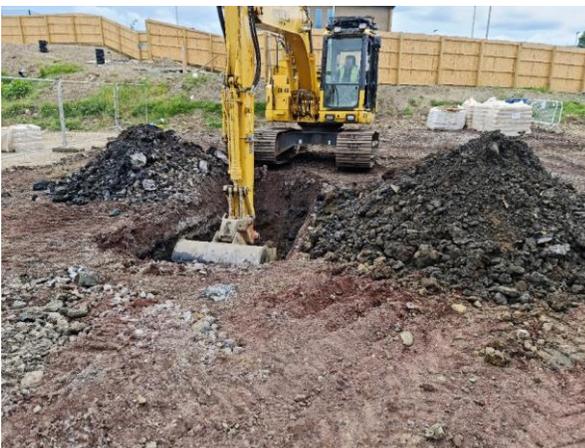
Figure 2 – Trial Pit Delineation

A series of small trial pits were excavated around the identified contaminated area to determine the vertical and lateral extent of the contamination. Two samples from the deepest recorded depth of contamination were used for base validation requirements (based on olfactory, VOC headspace analysis and rapid XRF testing). Side validation samples were taken from the outer external faces to confirm the lateral extent of the identified contamination (based on olfactory, VOC headspace analysis and rapid XRF testing). The trial pit delineation is shown in Figure 2 below and the rapid XRF testing is shown in Figure 3 below.

Laboratory analysis of the base and side validation samples confirmed that all samples were below the designated remediation target criteria, confirming that the vertical and lateral extent of the hydrocarbon contamination had been fully determined.

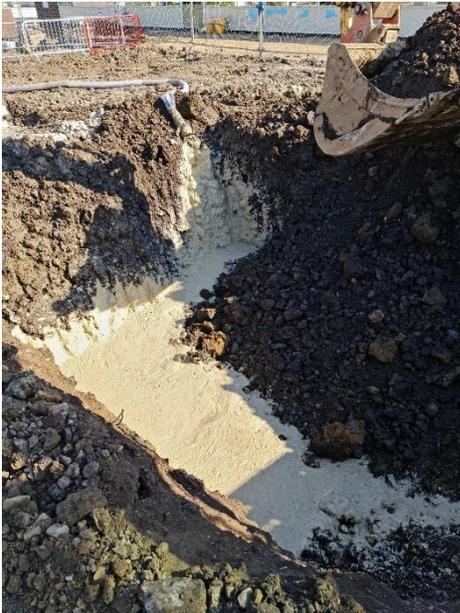
Figure 4 – *In-Situ* E-Clay Stabilisation

Identified contaminated soils were treated *in-situ* using an E-Clay formulation specifically designed to address the identified contaminants of concern.

The contaminated area was treated in discrete areas of known volume to ensure that the correct quantity of E-Clay was added (in slurry form).

A known volume of E-Clay was added to each area and soil mixed *in-situ* to the required depth using the excavator bucket.

The *in-situ* treatment process is shown in Figure 4 below.

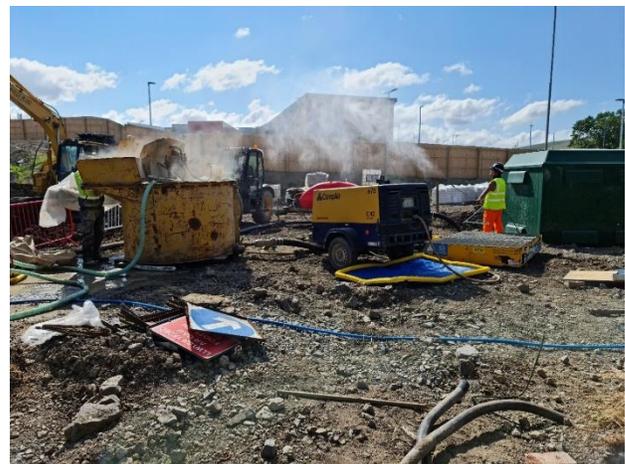
Figure 5 – Dust Suppression Employed During E-Clay Production On-Site

Dust suppression was also used during the handling of powdered treatment reagents as shown in Figure 5 below.
