Site Background & History

The former Techboard Facility was based on the Rassau Industrial Estate in Ebbw Vale. Techboard was a purpose-built manufacturer of hardboard and lauded as the largest venture capital backed greenfield development at the time.

Remediation Strategy

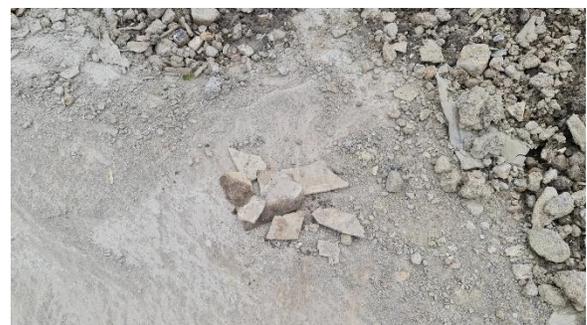
Figure 3 – Visible Asbestos Fragments

Envirotrat attended site in October 2021 and collected samples of the stockpiled materials to confirm potential asbestos fibre content and to evaluate other potential contaminants. Results confirmed asbestos fibre content to be <0.006% with slightly elevated TPH concentrations.

Visible asbestos fragments were noted during sampling as shown in Figure 3 below:

Visible cement bound asbestos fragments were picked by hand by a licensed asbestos subcontractor using the following procedure:

- The stockpiles were initially sprayed using water and a fibre suppressant
- Smaller manageable volumes of soil were removed from the stockpile using an excavator (circa 10m³) and set down on a clean area (whilst still spraying with fibre suppressant)
- Visible asbestos fragments were picked by hand and placed into double lined heavy duty plastic sacks
- Reassurance air monitoring was carried out throughout the picking process
- The plastic sacks were secured with tape and placed into the lined skip to await disposal.
- Once complete samples were collected for validation purposes

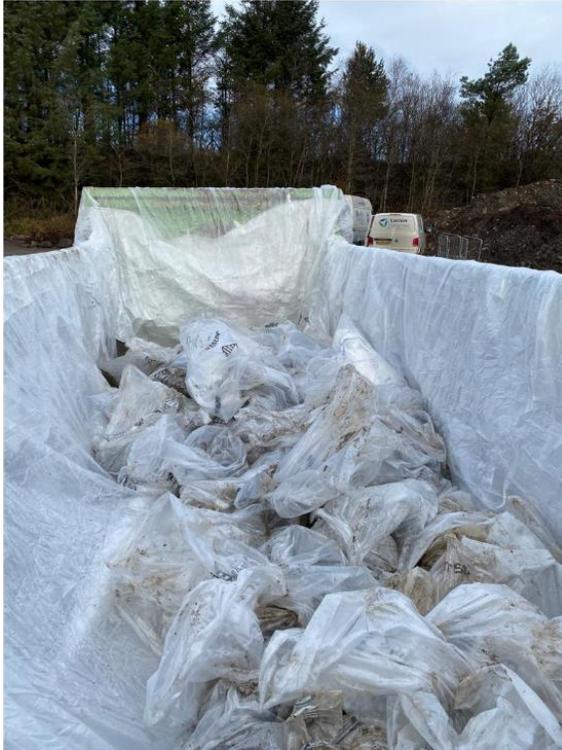
Figure 6 – Bagged Asbestos in Lined Skip

All bagged asbestos fragments were placed in a lined skip for disposal at a suitably licensed receiver site – this is shown in Figure 6 below.

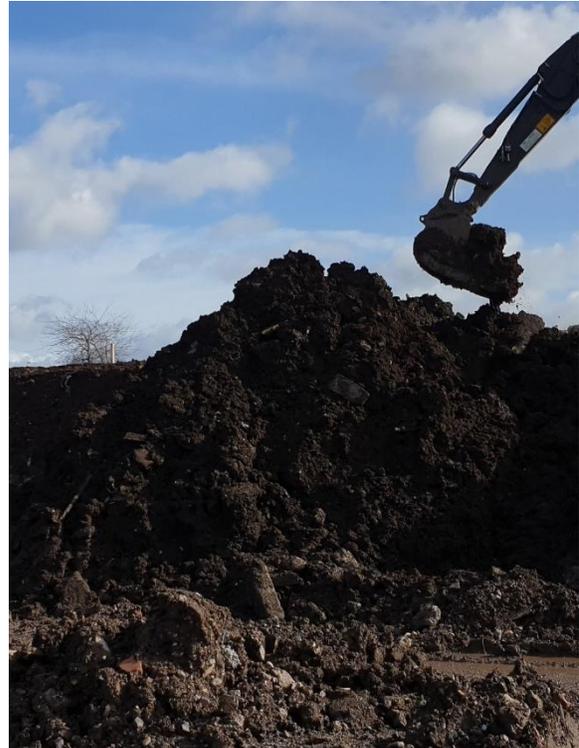
Figure 7 – Soil Treatment

A dry mix bentonite E-Clay was utilised for this project to address the identified TPH contamination and to also ensure the treated soil was suitable for reuse in the intended location.

Following completion of the asbestos picking, the dry mix E-Clay was added to the soil using an excavator as shown in Figure 7 below. On completion several validation samples were collected and submitted to a UKAS/MCERTS laboratory for appropriate analysis.

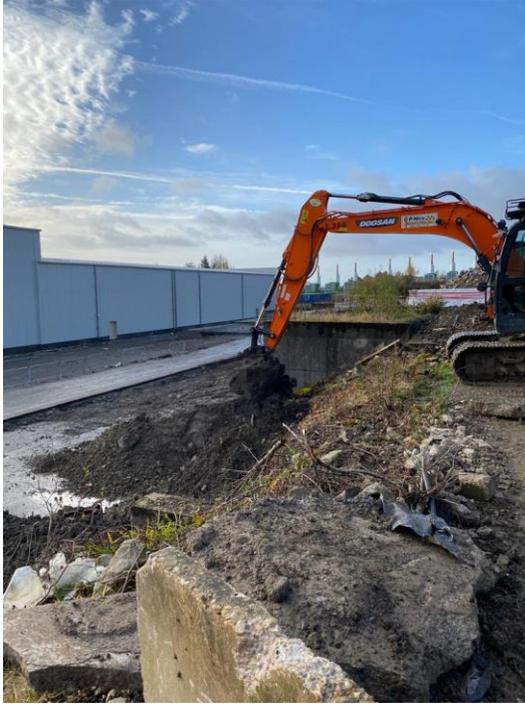
Figure 8 – Soil Emplacement

The treated and validated soil was emplaced into voids allocated for soft landscaping, covered with an anti-dig membrane, and capped with 600 mm of clean soil. This is shown in Figures 8 – 10 below.
